Final Report

CALFED Water Use Efficiency Program

Yolo County Resource Conservation District Pilot Program 2001

May 2002

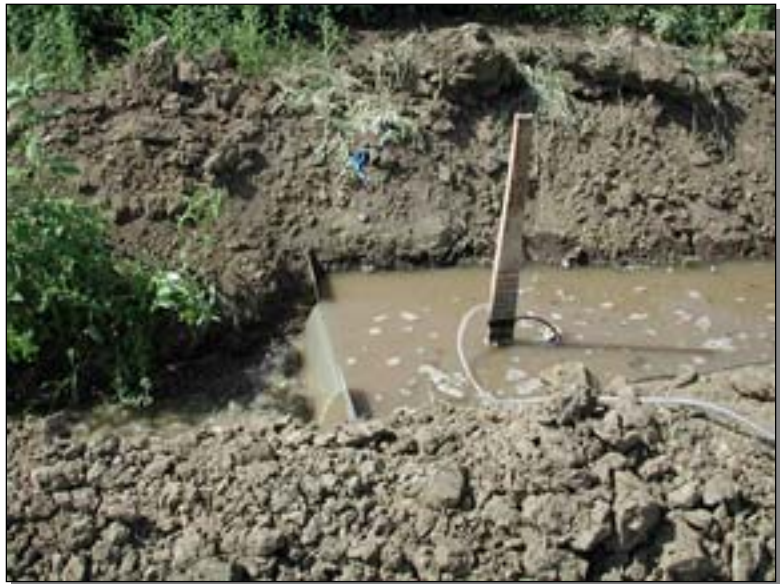
Figure 55: A side view of the weir arrangement

At this site in-ditch weir installation was problematic because the ditch was already wet and we could not establish a sufficiently adequate “seal” around the weir to prevent runoff water from escaping under or around the structure. In response, RCD staff modified a flashboard to serve as a rectangular notch weir in the existing drop structure to measure Outflow (runoff) from the field paired with the 900MAX PORTABLE SAMPLER. The weir was designed from two pieces of ½” plywood attached together to form a 1” thick piece so that it would fit tightly in the flash board structure in field D1 as seen in Figure 56 on the following page. A rectangular notch was then cut into the board (using a circular saw) as seen below. The horizontal portion of the cut mitered to a 45-degree angle to create the sharp edge effect needed in weirs.

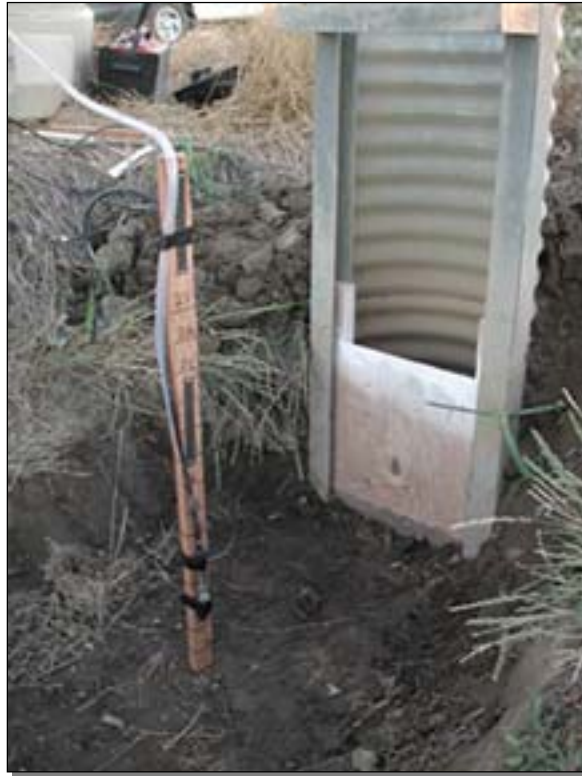
*Figure 56: Modified
flashboard riser
(Rectangular notch weir)
installed at field D1*

The process of design was easy and construction was inexpensive (\$50 in materials and 5 man-hours). The weir was used successfully in the field with no problems. Determining the runoff rate over the weir was accomplished with the 900MAX sampler, which measured the depth of water on top of the weir notch. This method introduces less error than using the regular flashboards that are found in the fields. This device was used to record water level on top of the pressure sensor and also to collect runoff samples every two hours. Water level values were then used to calculate the volume of runoff.

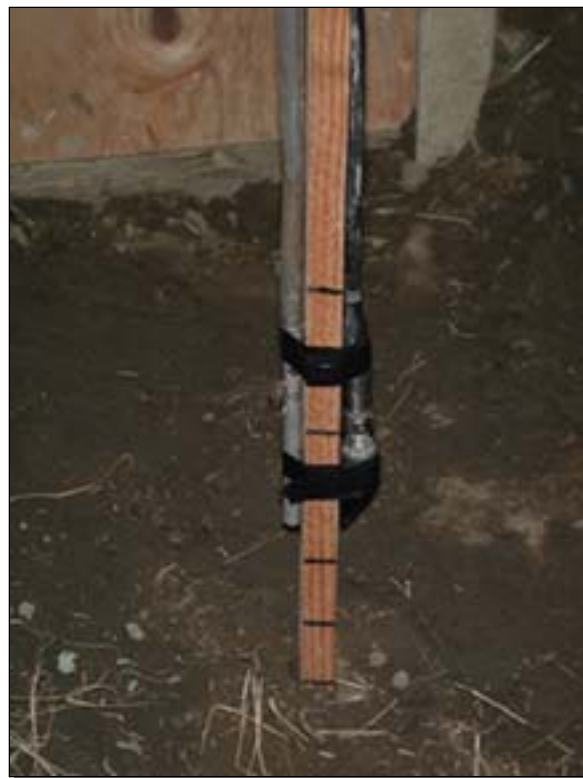
Figure 57: Pressure transducer can be seen on the right and the water sampling intake tube can be seen on the left

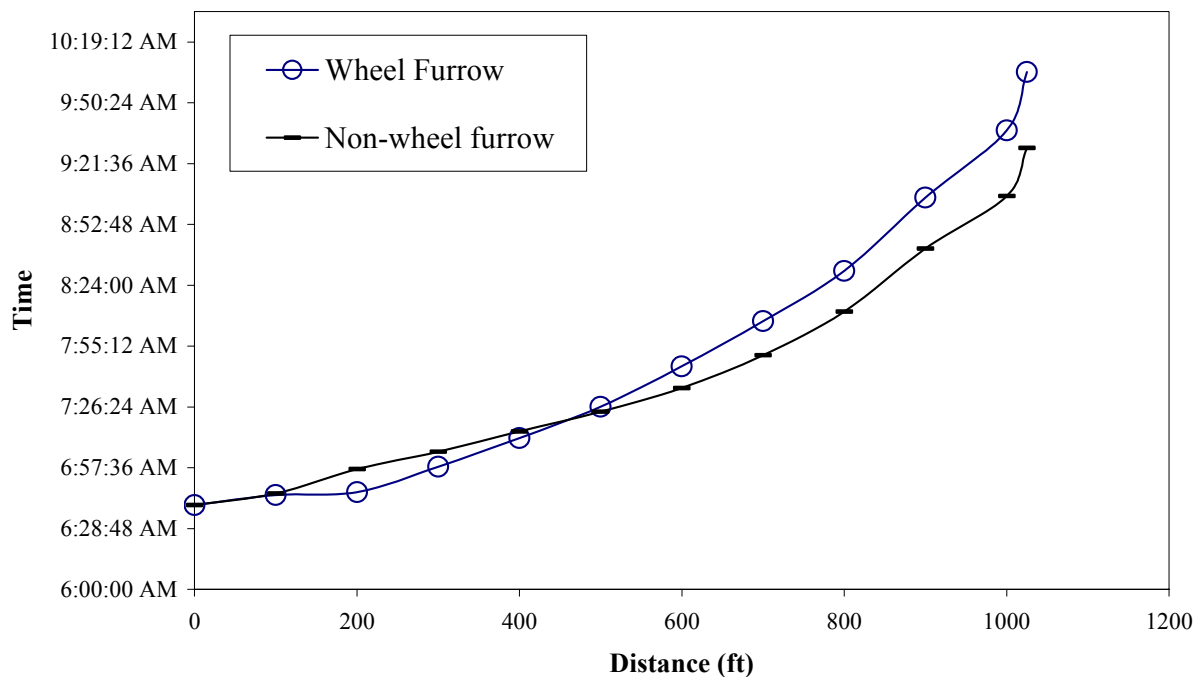
Figure 58: Water advance curves for a wheel and a non-wheel furrow in Field A1.

Advance rate across furrows was measured in 100 ft (Field A1) or 200 ft (Field D1) increments and was found to vary between wheel and non-wheel furrows.

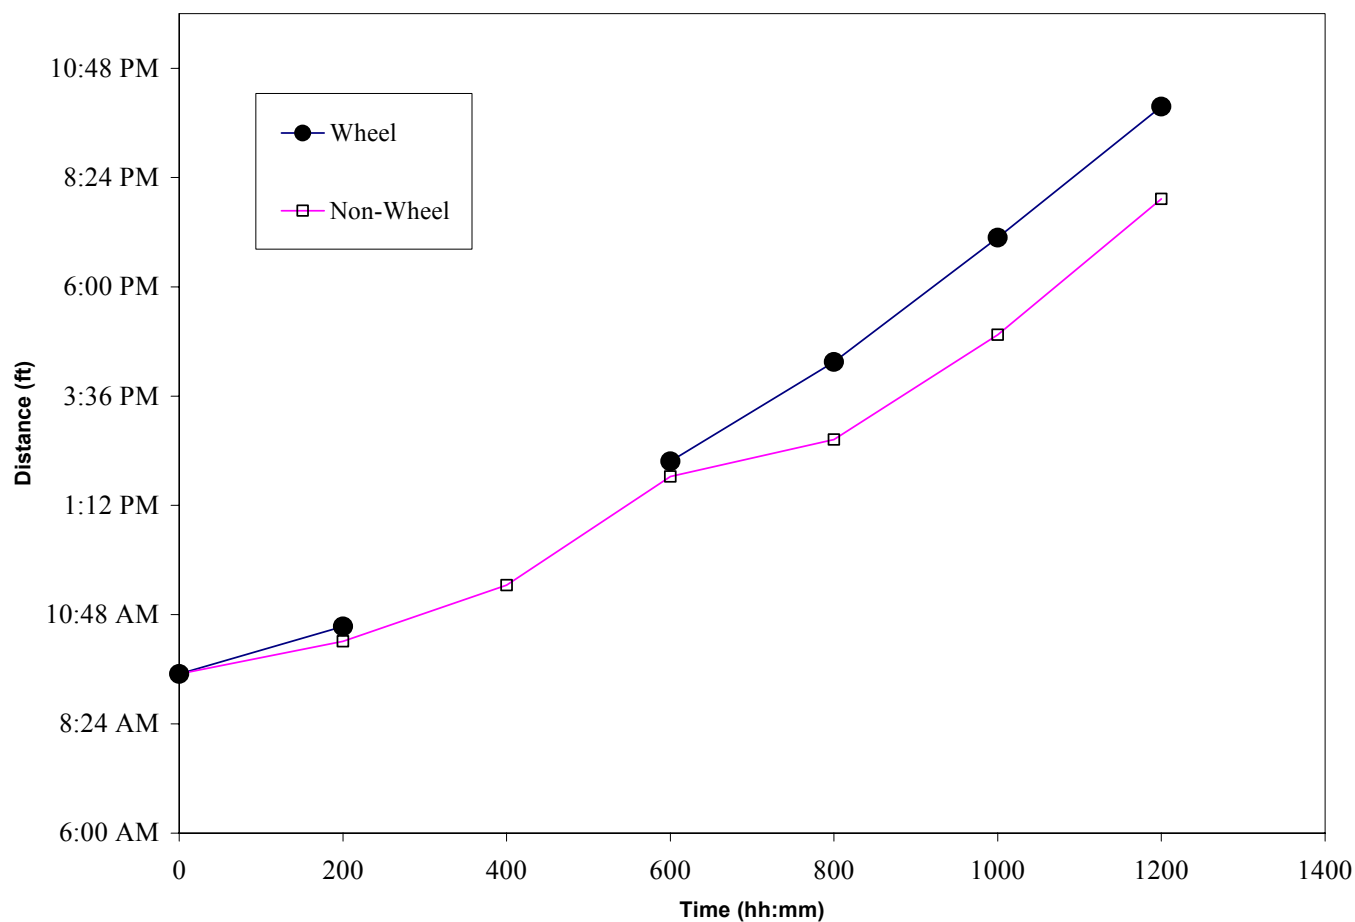
Figure 59: Average advance curves for the wheel and non-wheel furrows in Field D1 on July 20, 2001
